AN INVESTIGATION OF DEFECTS IN REPAIR WORK OF ROOF SLAB OF ACADEMIC BLOCK AT JUIT, HP, INDIA

Abstract: Jaypee University of Information Technology is located at Waknaghat; in district Solan of Himachal Pradesh state, India. It is situated in hilly area and due to orographic precipitation the weather here is rainy. Therefore buildings may face problem of dampness and water leakage. Due to large diurnal temperature variation and alternate wetting and drying conditions, cracks appear on the surface of concrete. A crack was observed at the time of placement of conduits pipe after casting of the slab. Pipe was concealed using a rich mix of mortar. Here the defect has been appeared due to the internal cracks in concrete slab. Water percolating from this crack is creating appearance of white scales on the repair work and this is ruining the appearance of slab too. This defect on the slab was due to calcium carbonate efflorescence. In this paper, remedies for the presented calcium carbonate efflorescence are suggested.

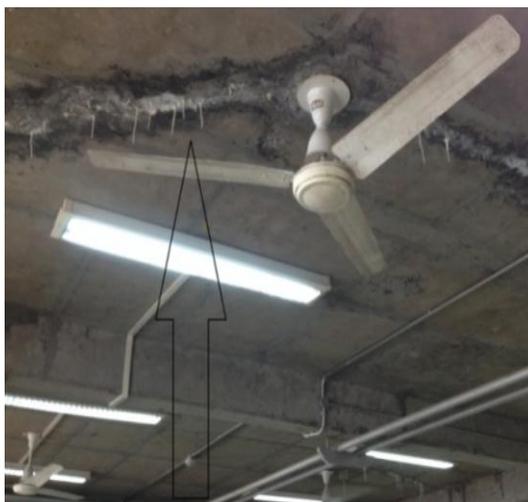
The internal cracks in concrete slab are believed to be the prime cause of this type of defects. In hilly area, due to orographic precipitation, moisture content in this region is high and the buildings here may face the problem of dampness and water leakage. A white scaling with percolating water is observed under roof slab in the academic block (5th floor) of JUIT, Waknaghat. The prime cause of white scaling (as shown in Figure 1 and 2) defect was a chocking of conduits pipe after casting of slab due to any weight and at the time of wiring these chocked pipes are replaced by new ones. It is observed that during the chiseling of concrete slab for replacement of conduits pipe, the internal cracks has been appeared in the slab. On that repair position a whitish material (lime) appeared.

Figure 1: White scaling under roof slab

At the surface of concrete, the water evaporates into air but salt cannot vaporize under normal conditions hence it gets deposits onto the surface which causes these white spots on the surface. From Figure1 and Figure 2 the slab defects are clearly visible; the whitish bloom material has appeared on the repaired position of slab. Dropout of whitish bloom material on floor due to continue water leakage in slab are shown in Figure 3. To find out the type of material which has appeared on the surface of defective slab, alkalinity test of material was performed.

- The first step is to removing the tiles from effected area.
- Removing mud plastering from effected area and clean out the surface by steel brushing.
- Treatment of appear hair crack line by making "V" grove and by using Adhesive bonding.
- Apply water proofing over the area by using cico or tapcrete.
- Plastering of the surface of 25 mm thickness over the water proofing area by taking cement-sand ratio of 1:4.

- At bottom level clean out surface and after mud plastering use 2 coat of paint as primer and putty.
- Curing is very important of repaired surface.

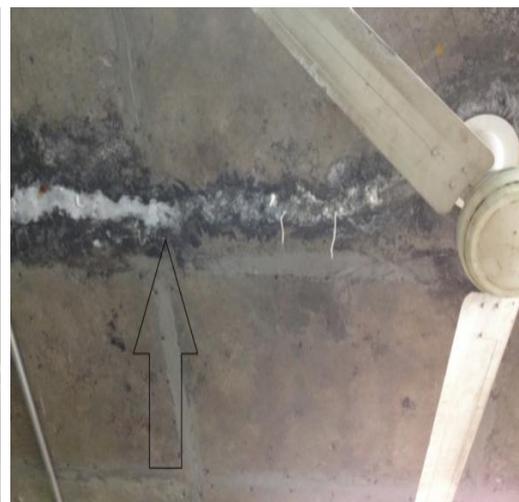
Figure 2: Prime cause of white scaling

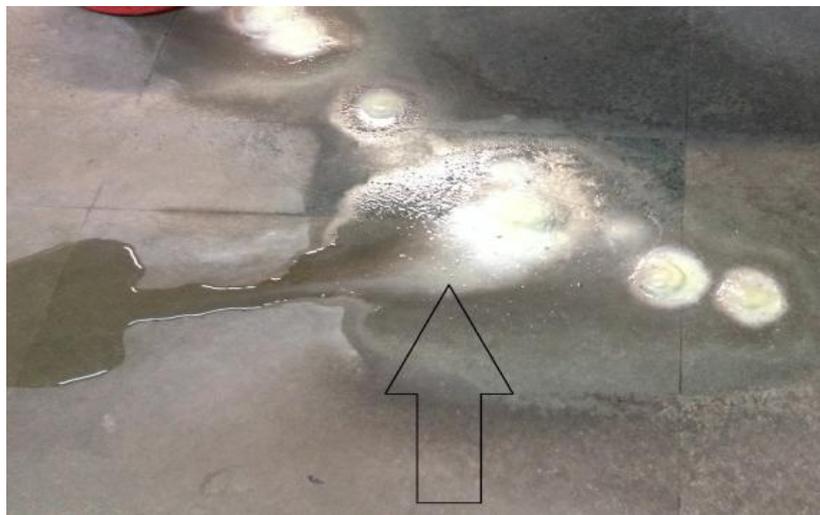
Figure 3: Dropout of whitish bloom material on floor

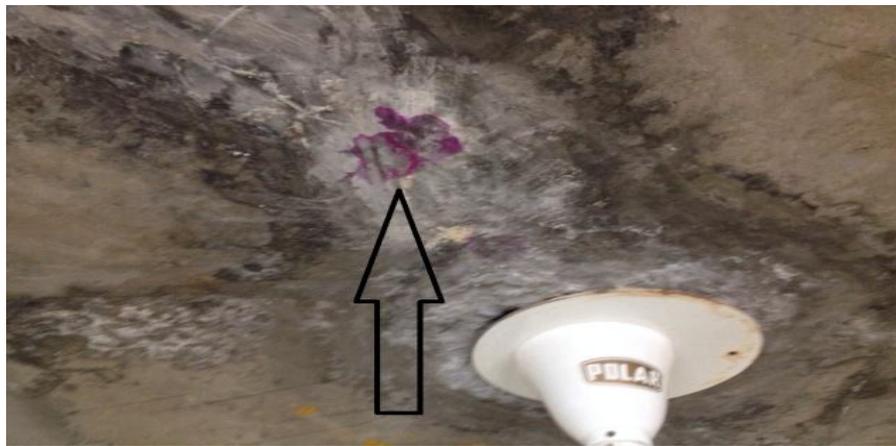
This test is carried out to determine the depth of concrete affected due to combined attack of atmospheric carbon dioxide and moisture causing a reduction in level of alkalinity of concrete. A spray of 0.2% solution of phenolphthalein is used as pH indicator of concrete. The change of colour of concrete to pink indicates that the concrete is in the good health, where no change in colour takes place; it is suggestive of carbonation-affected concrete. The test is conducted by drilling a hole on the concrete surface to different depths up to cover concrete thickness, removing dust by air blowing, spraying phenolphthalein with physician's injection syringe and needle on such freshly drilled concrete and observing the colour change. This test was performed on the defected part of the slab and on white deposits as well. The colour turned pink in both the cases. Therefore, it means the concrete is in good health and not affected by carbonation.

Figure 4: Pink colour after spraying of phenolphthalein

From Figure 4 it can be seen that after spraying of phenolphthalein indicator in cracks and in drilled hole, appearance of pink colour is observed. It shows the concrete is not affected by carbonation.
